ASBESTOS SURVEY REPORT

Old Harris County District Attorney Building
(Ten Story Vacant Office Building with Basement, Penthouse & Roof)
201 Fannin
Houston, Texas 77002

Project Number:
B-217122R

May 22, 2017
Revised July 27, 2017

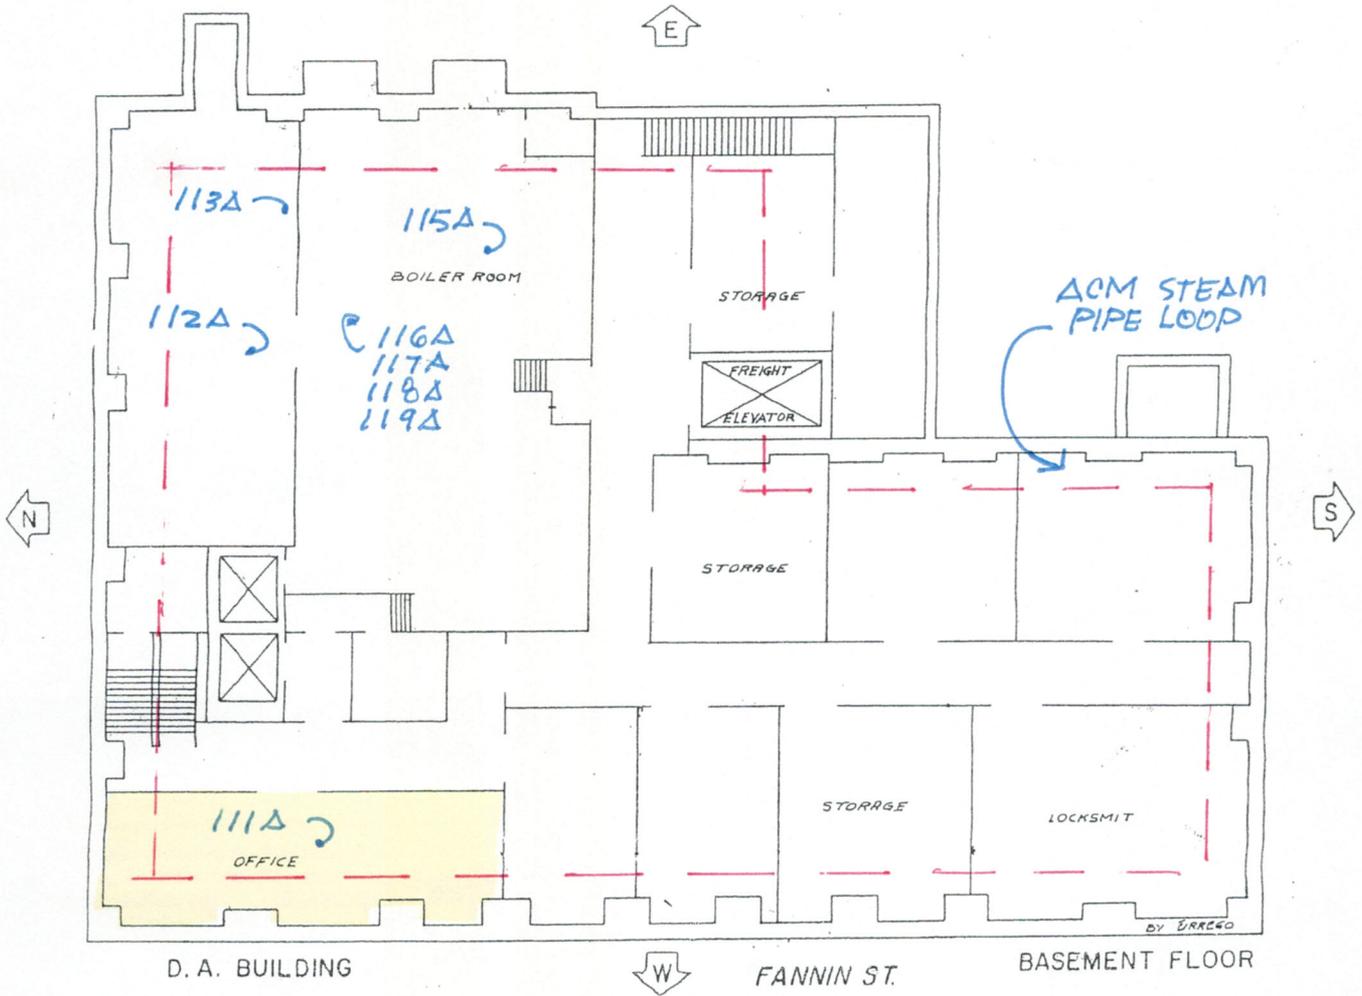
BASEMENT FLOOR PLAN.....NO SCALE

- REPRESENTS AREAS OF IDENTIFIED OR ASSUMED ACM FLOOR TILE AND/OR MASTIC

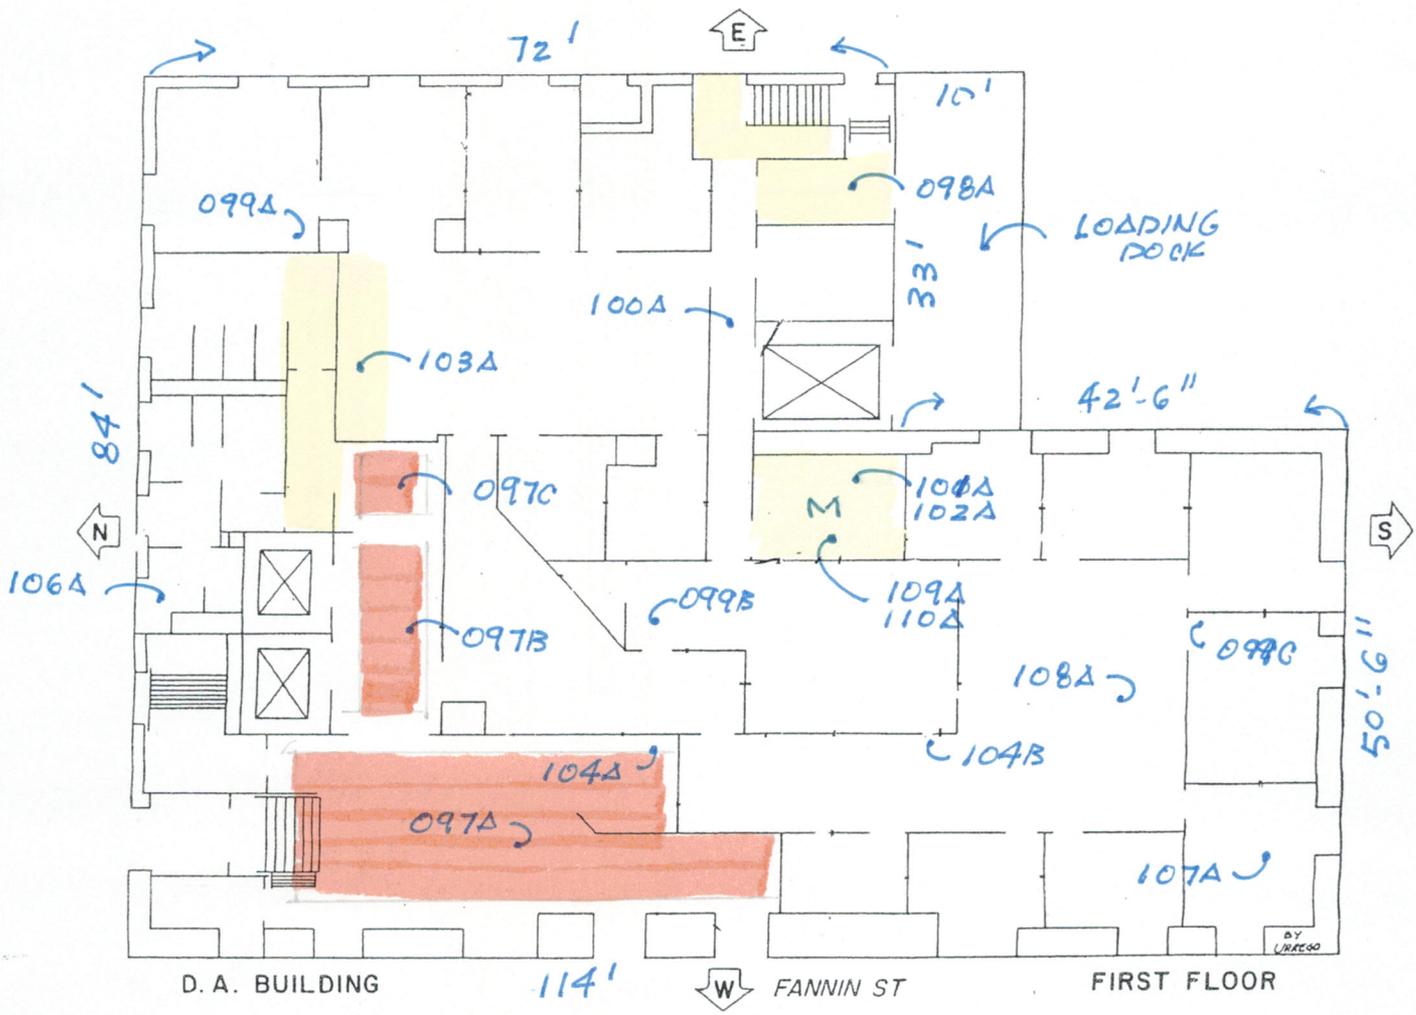
FIRST FLOOR PLAN.....NO SCALE

- 001A - REPRESENTS ASBESTOS SAMPLE LOCATION
- REPRESENTS AREAS OF IDENTIFIED OR ASSUMED ACM FLOOR TILE AND/OR MASTIC
- REPRESENTS AREAS OF IDENTIFIED ACM ACOUSTICAL CEILING TEXTURE ON PLASTER

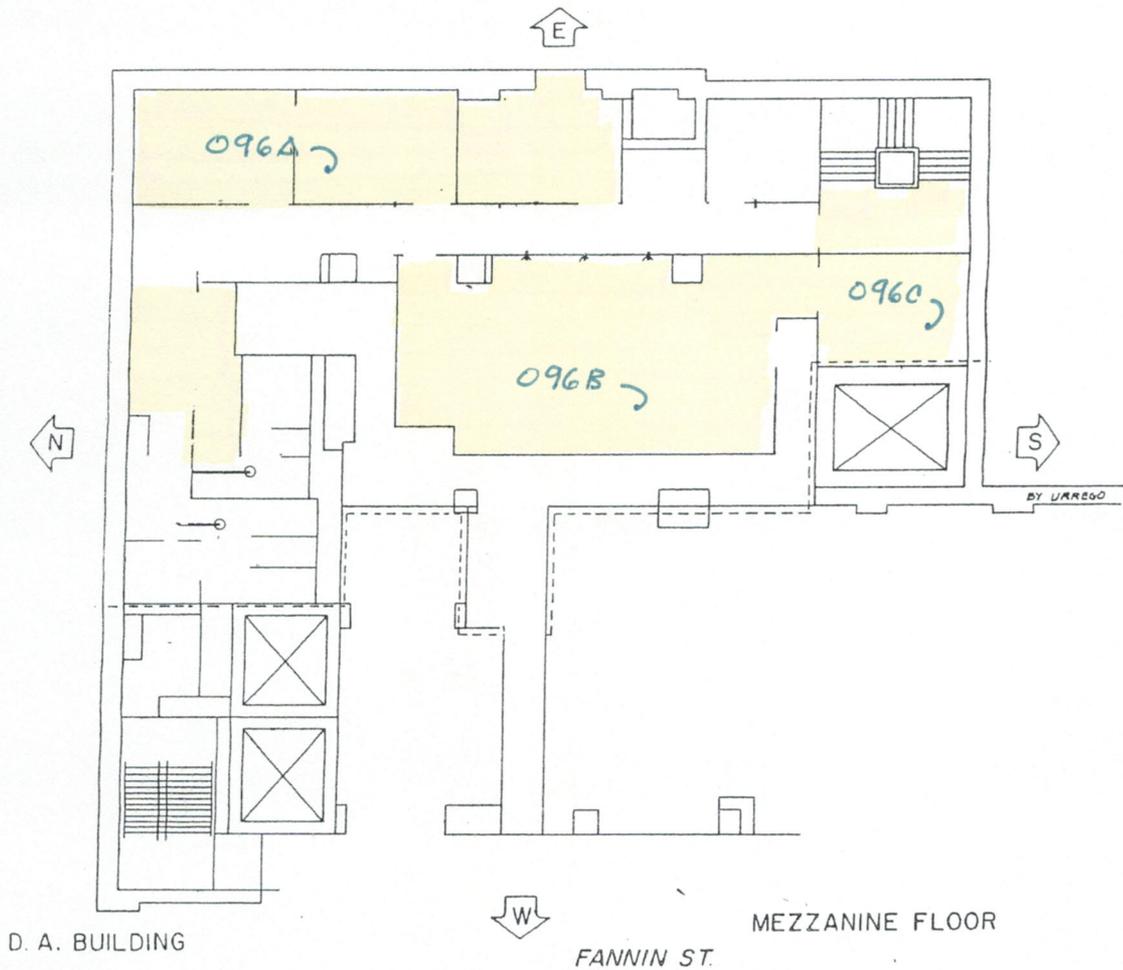
FIRST FLOOR MEZZANINE FLOOR PLAN.....NO SCALE

- REPRESENTS AREAS OF IDENTIFIED OR ASSUMED ACM FLOOR TILE AND/OR MASTIC

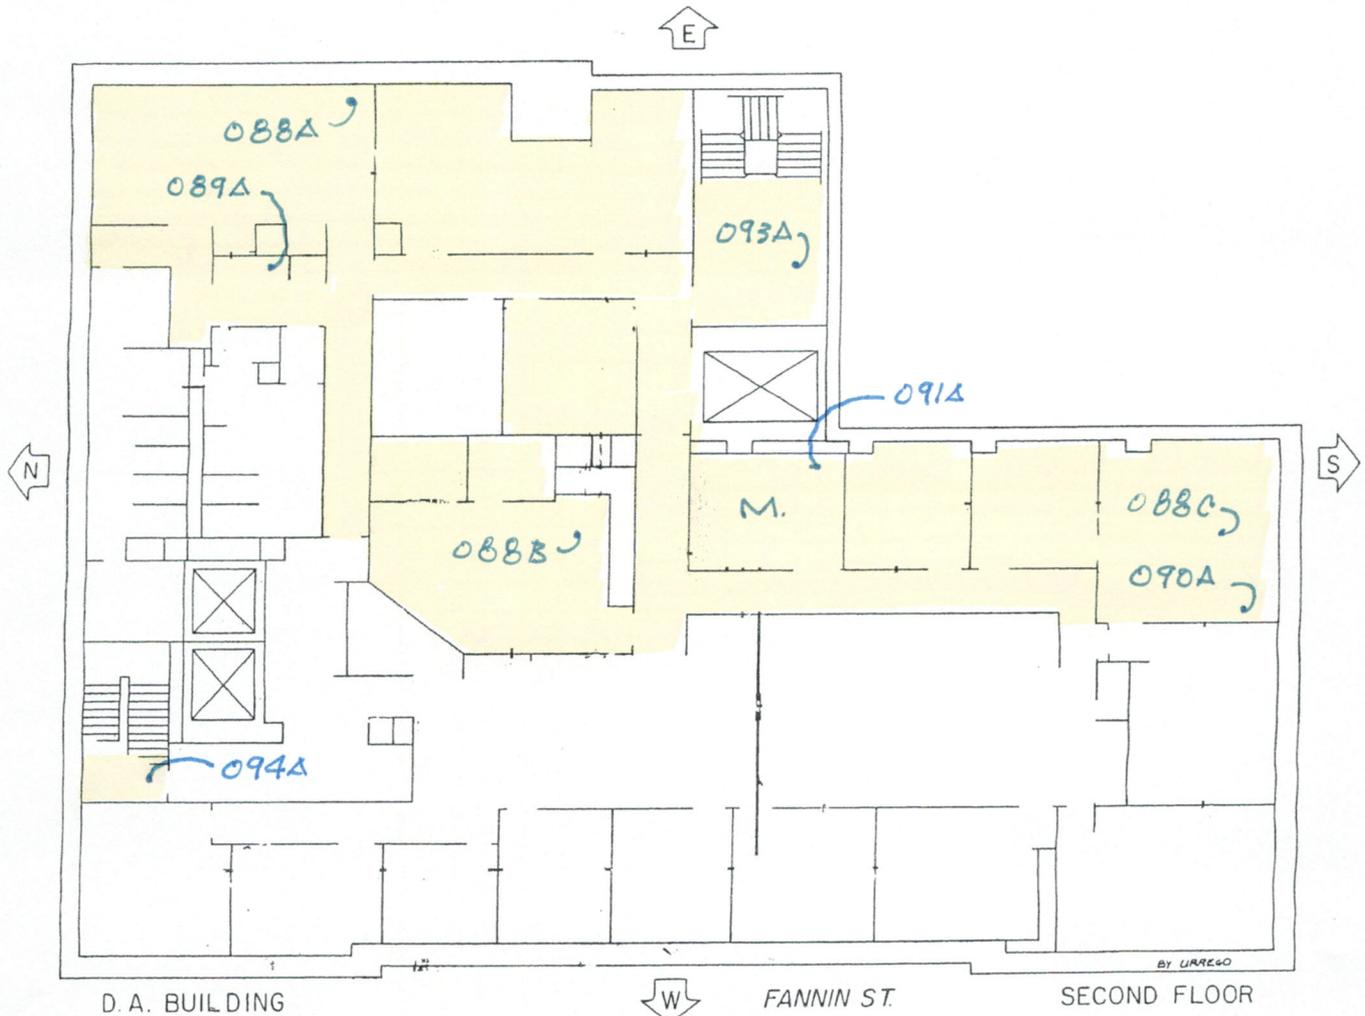
SECOND FLOOR PLAN.....NO SCALE

- REPRESENTS AREAS OF IDENTIFIED OR ASSUMED ACM FLOOR TILE AND/OR MASTIC

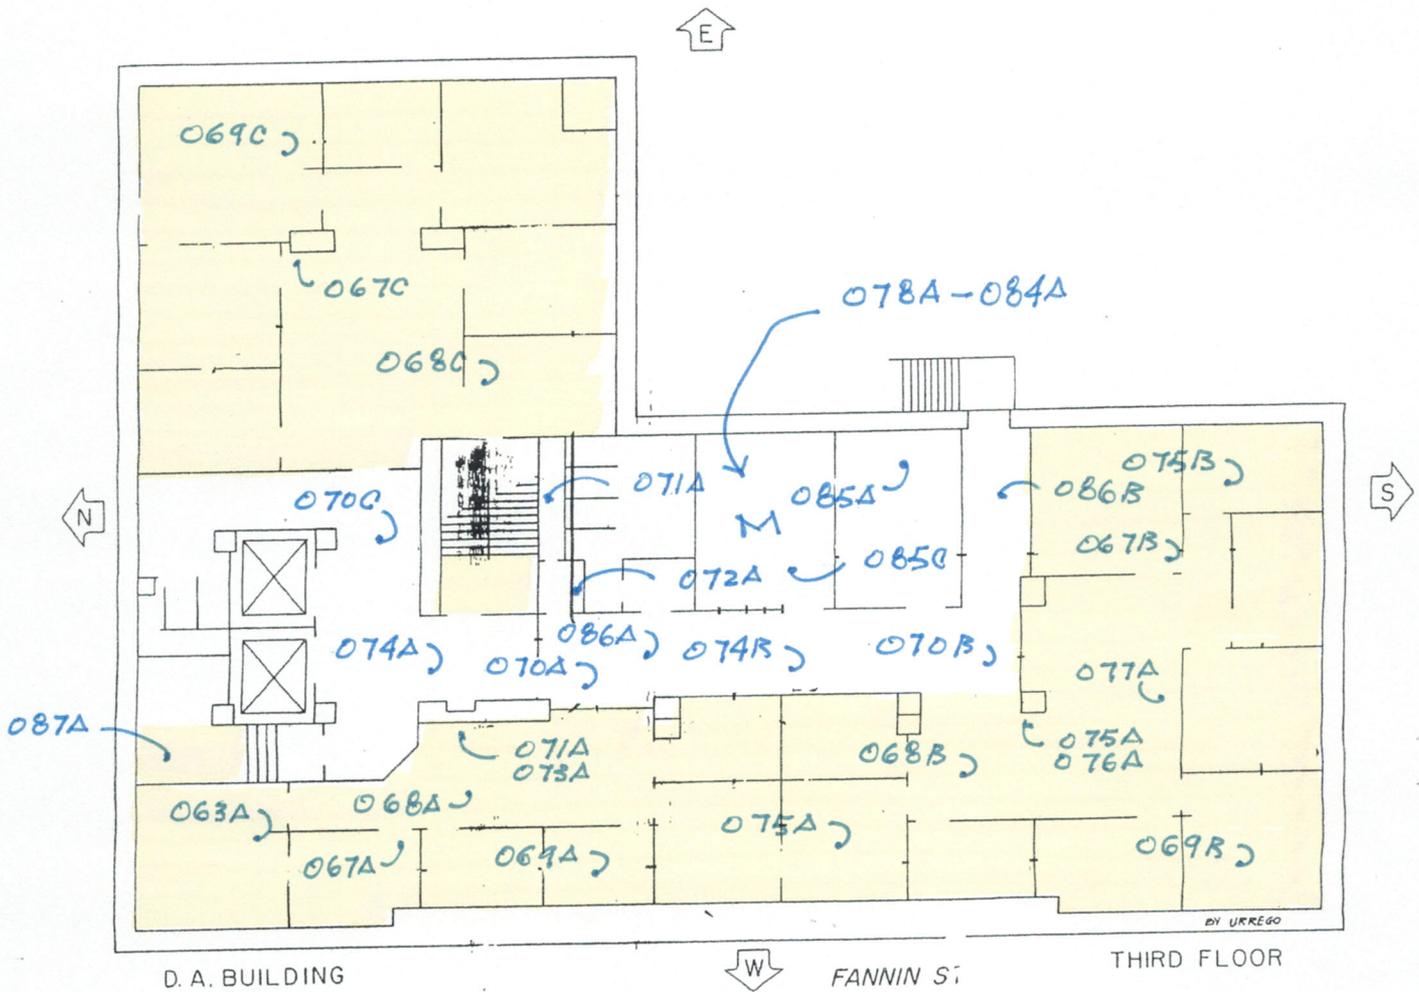
THIRD FLOOR PLAN.....NO SCALE

- REPRESENTS AREAS OF IDENTIFIED OR ASSUMED ACM FLOOR TILE AND/OR MASTIC

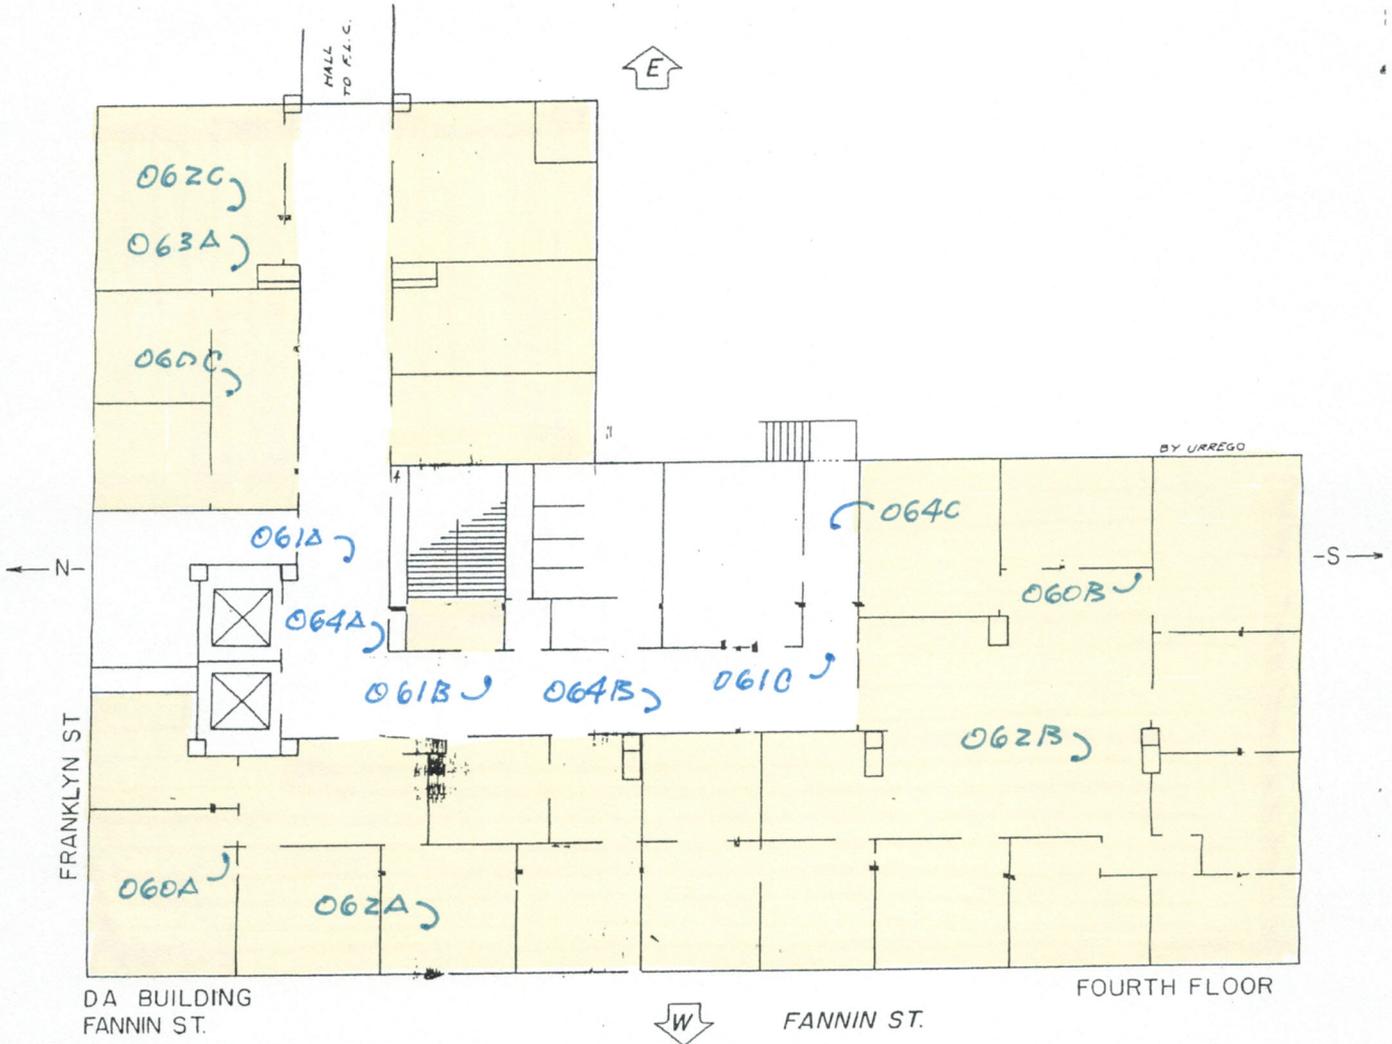
FOURTH FLOOR PLAN.....NO SCALE

- REPRESENTS AREAS OF IDENTIFIED OR ASSUMED ACM FLOOR TILE AND/OR MASTIC

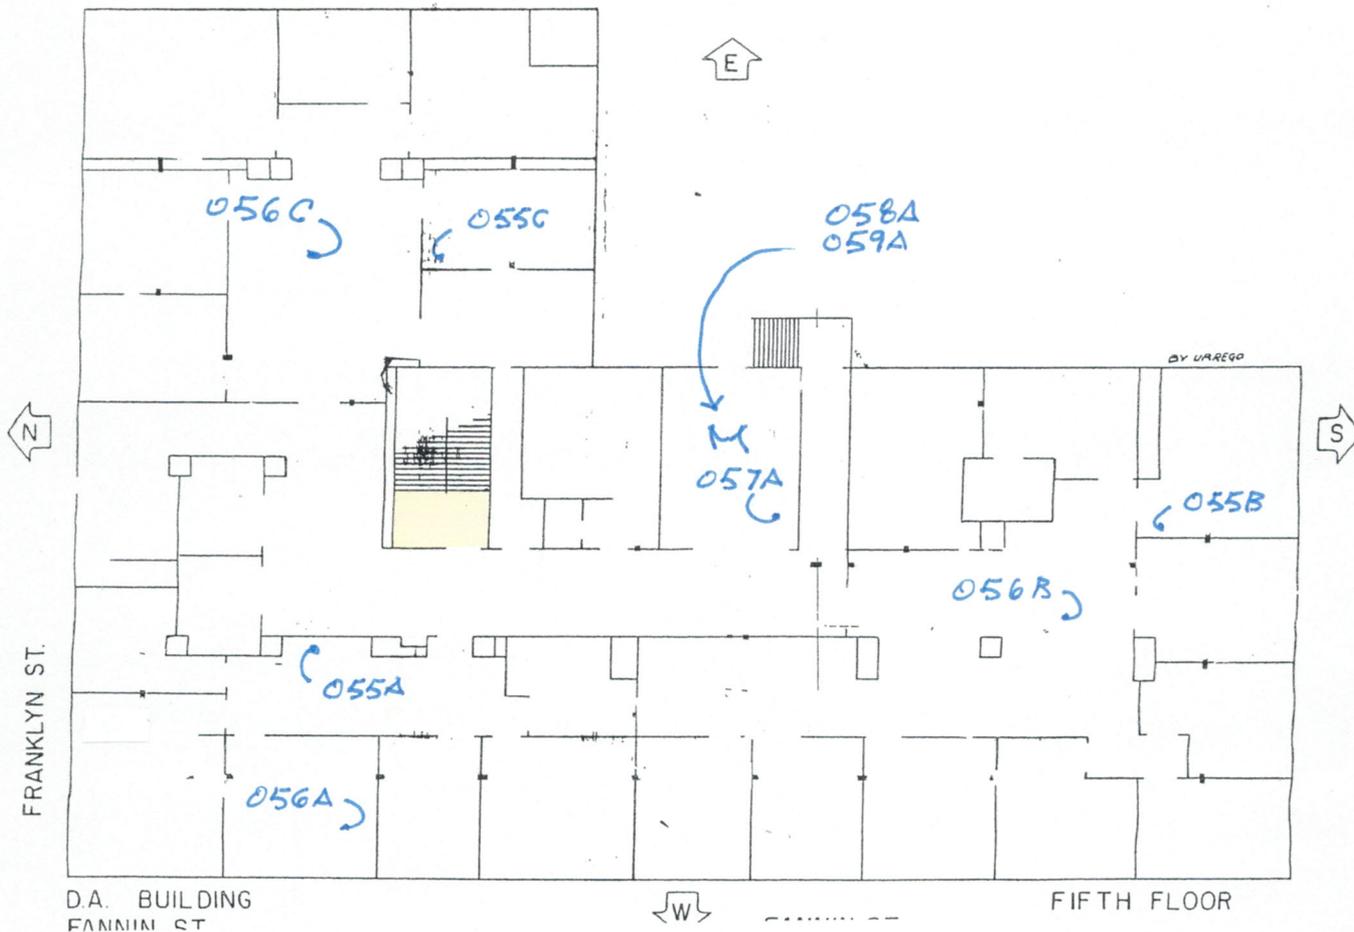
FIFTH FLOOR PLAN.....NO SCALE

- REPRESENTS AREAS OF IDENTIFIED OR ASSUMED ACM FLOOR TILE AND/OR MASTIC

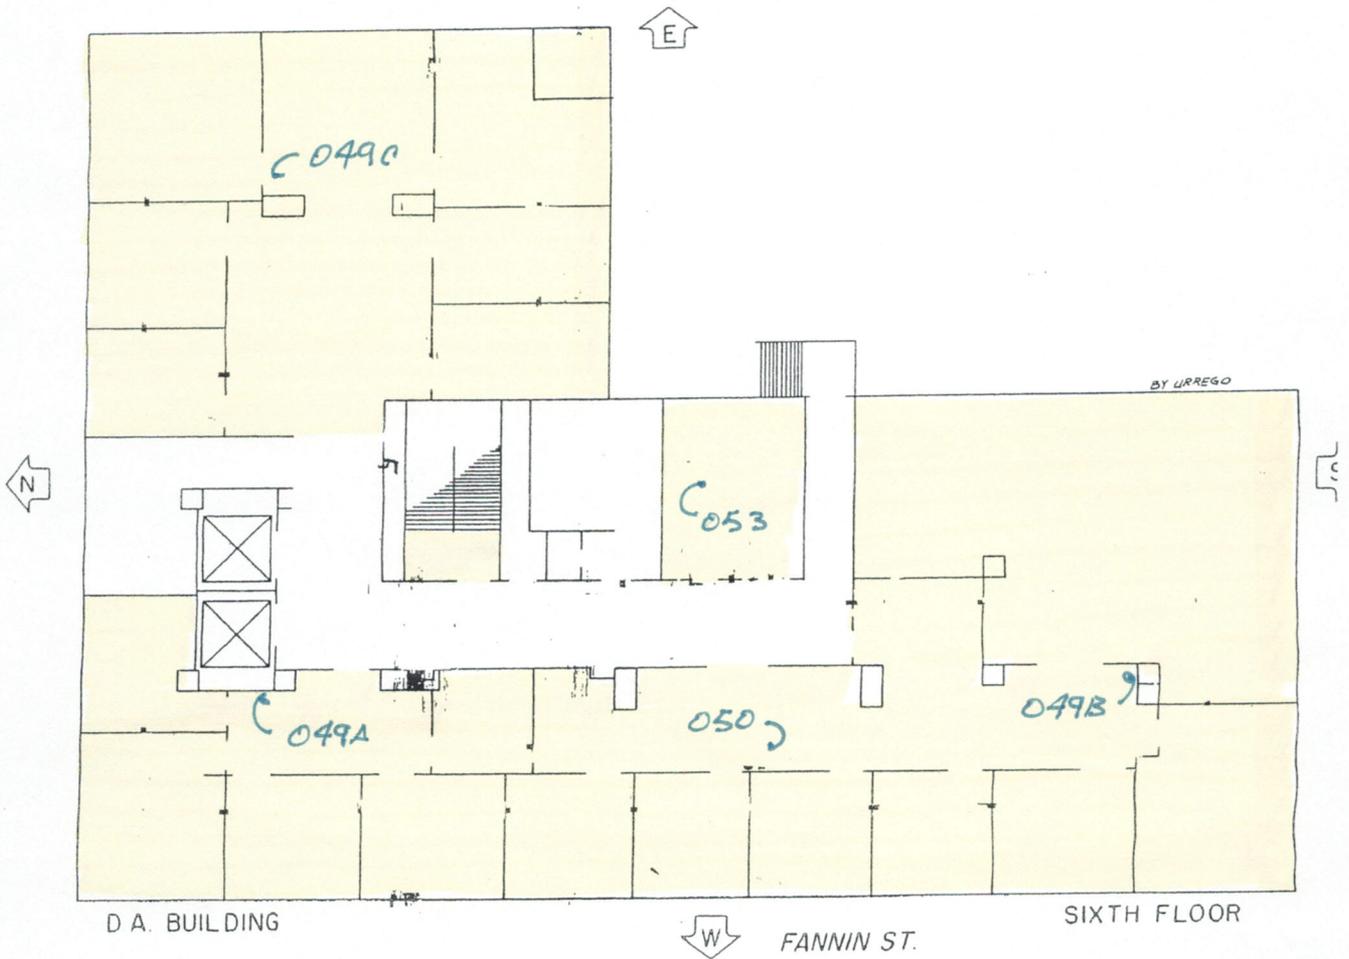
SIXTH FLOOR PLAN.....NO SCALE

- REPRESENTS AREAS OF IDENTIFIED OR ASSUMED ACM FLOOR TILE AND/OR MASTIC

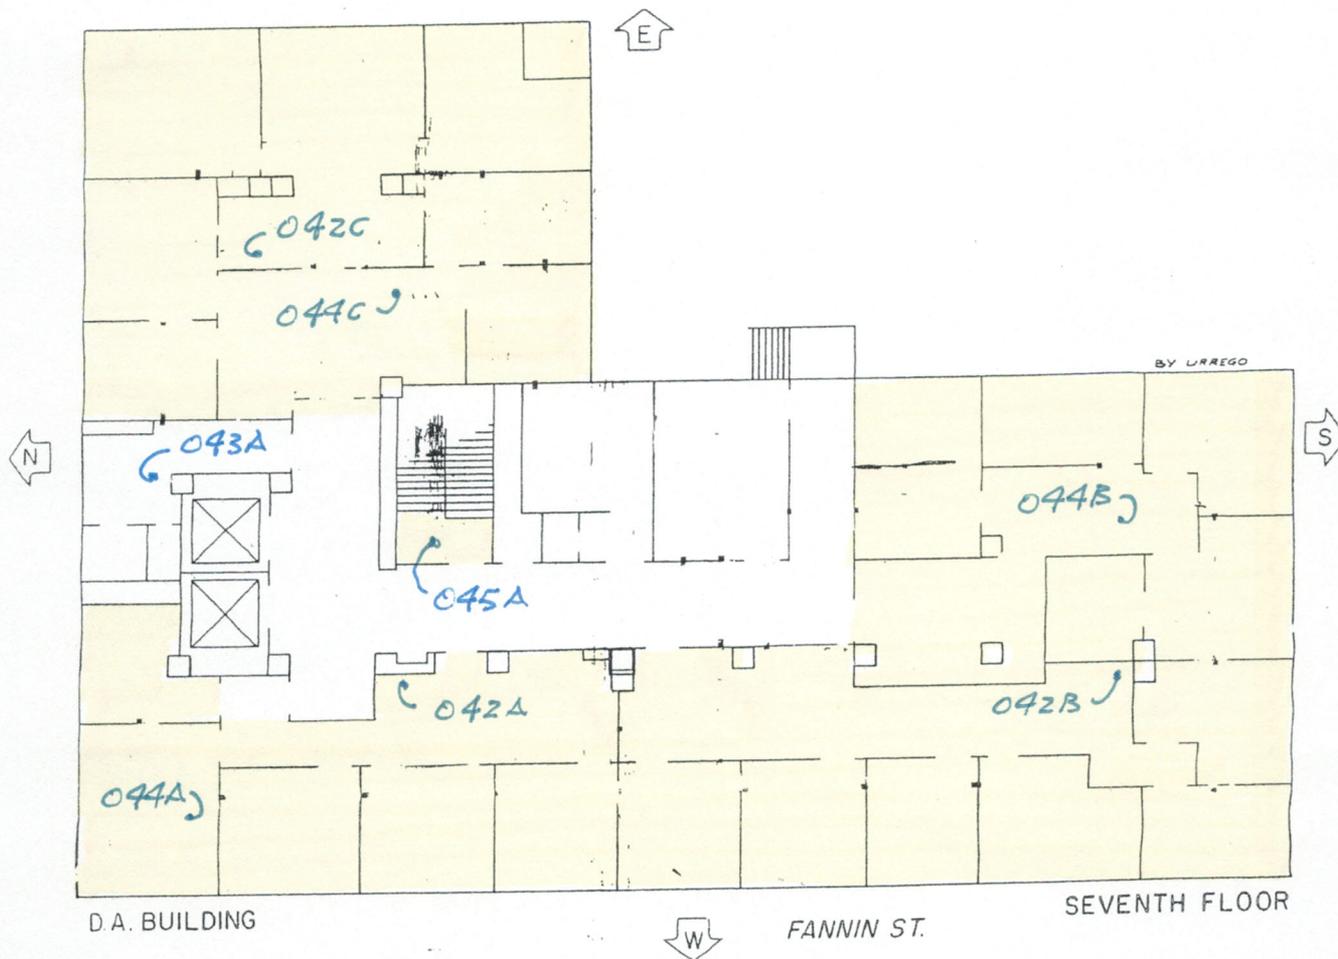
SEVENTH FLOOR PLAN.....NO SCALE

- REPRESENTS AREAS OF IDENTIFIED OR ASSUMED ACM FLOOR TILE AND/OR MASTIC

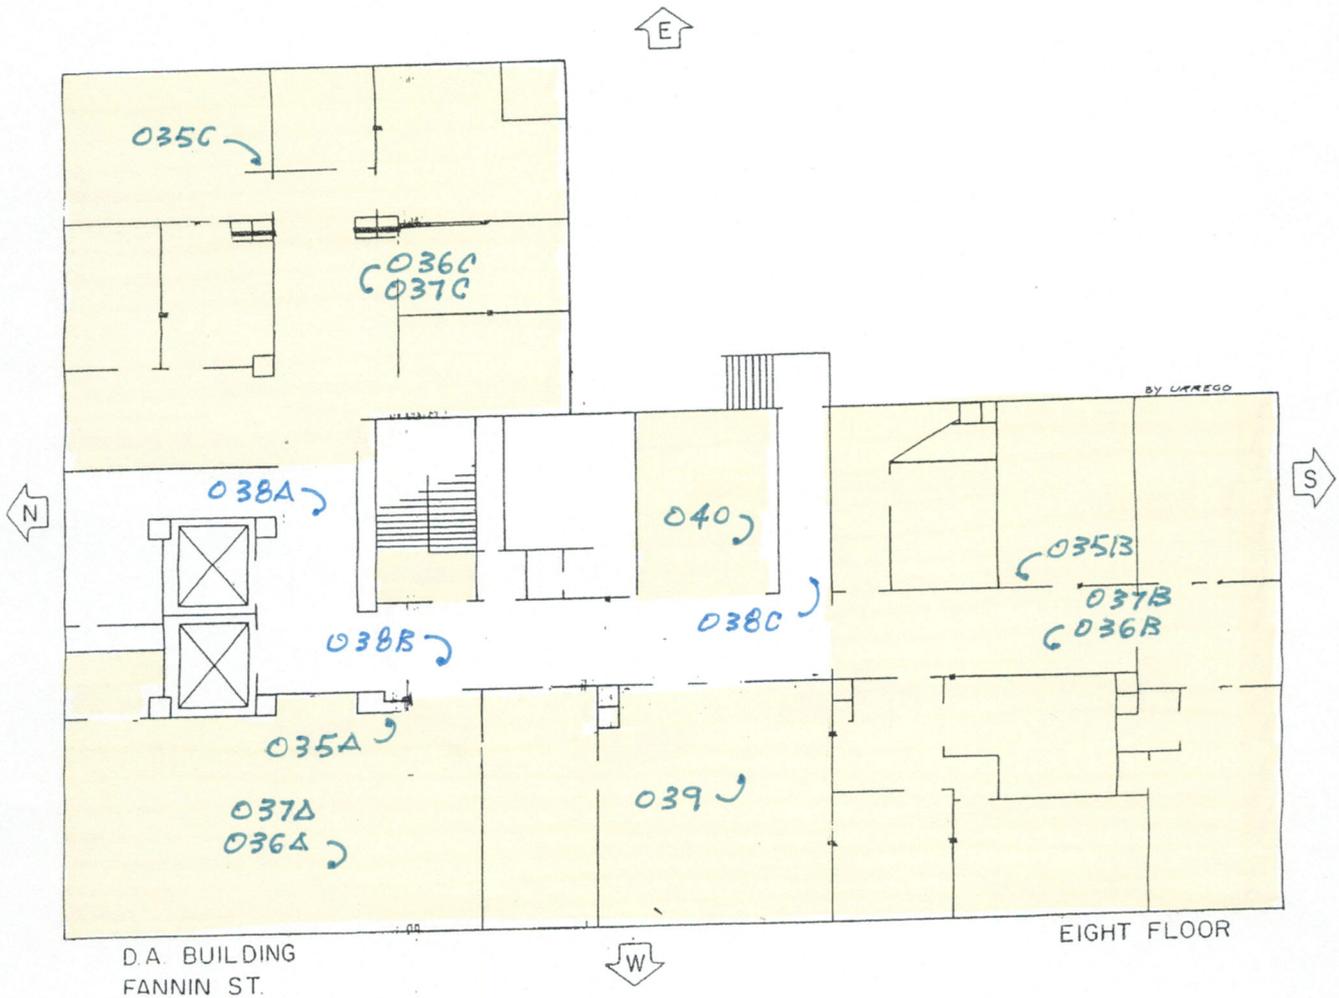
EIGHTH FLOOR PLAN.....NO SCALE

- REPRESENTS AREAS OF IDENTIFIED OR ASSUMED ACM FLOOR TILE AND/OR MASTIC
